SOUTHWEST CONNECTICUT RELIABILITY PROJECT

THE CONNECTICUT LIGHT AND POWER COMPANY

VOLUME 2: WETLANDS AND WATERCOURSES REPORT

VOLUME 3: ENVIRONMENTAL

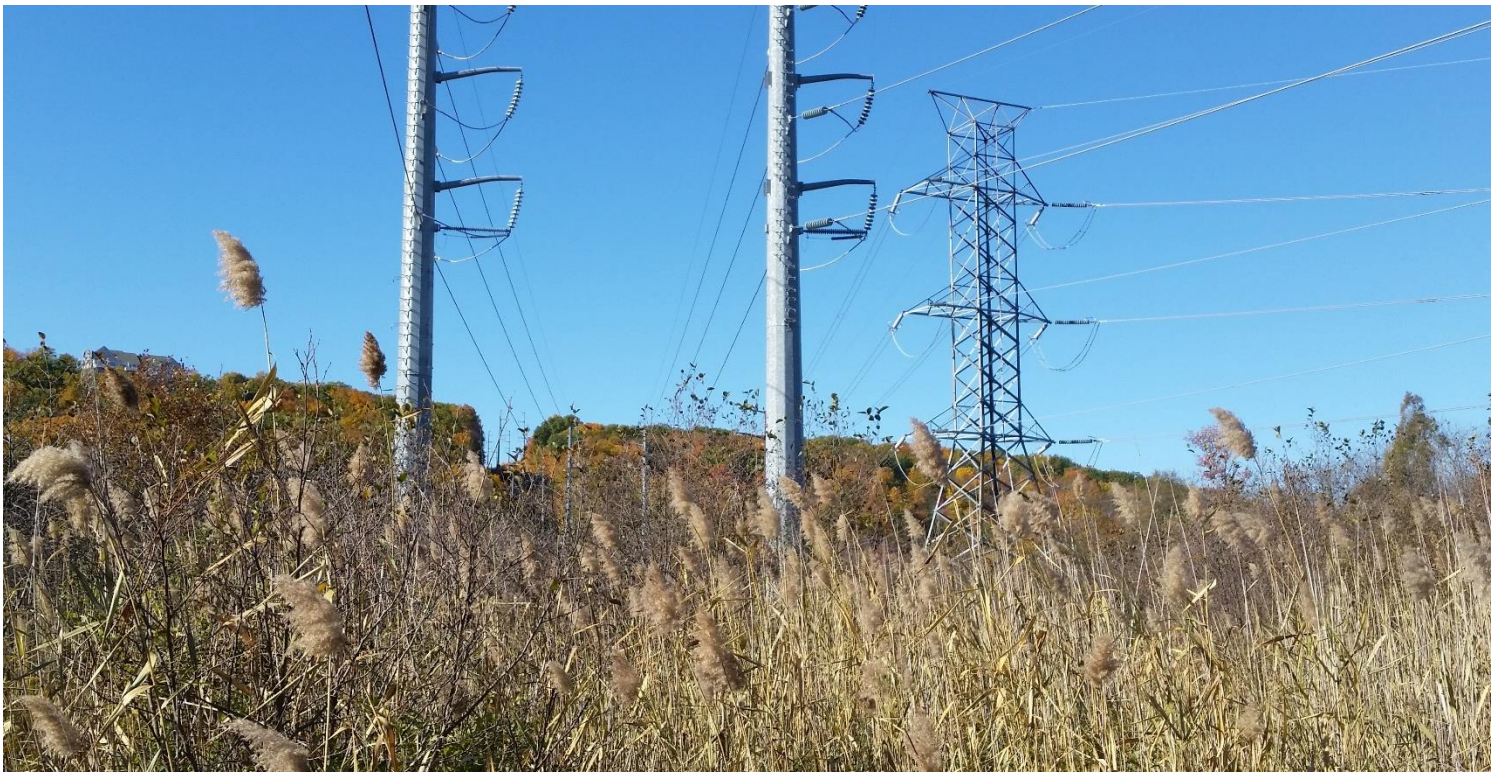
Photo #1: View of Wetland W-1 from the west side of the Plumtree Substation. Existing 321 Line Structure 10269 is shown on the right. *Facing West.*

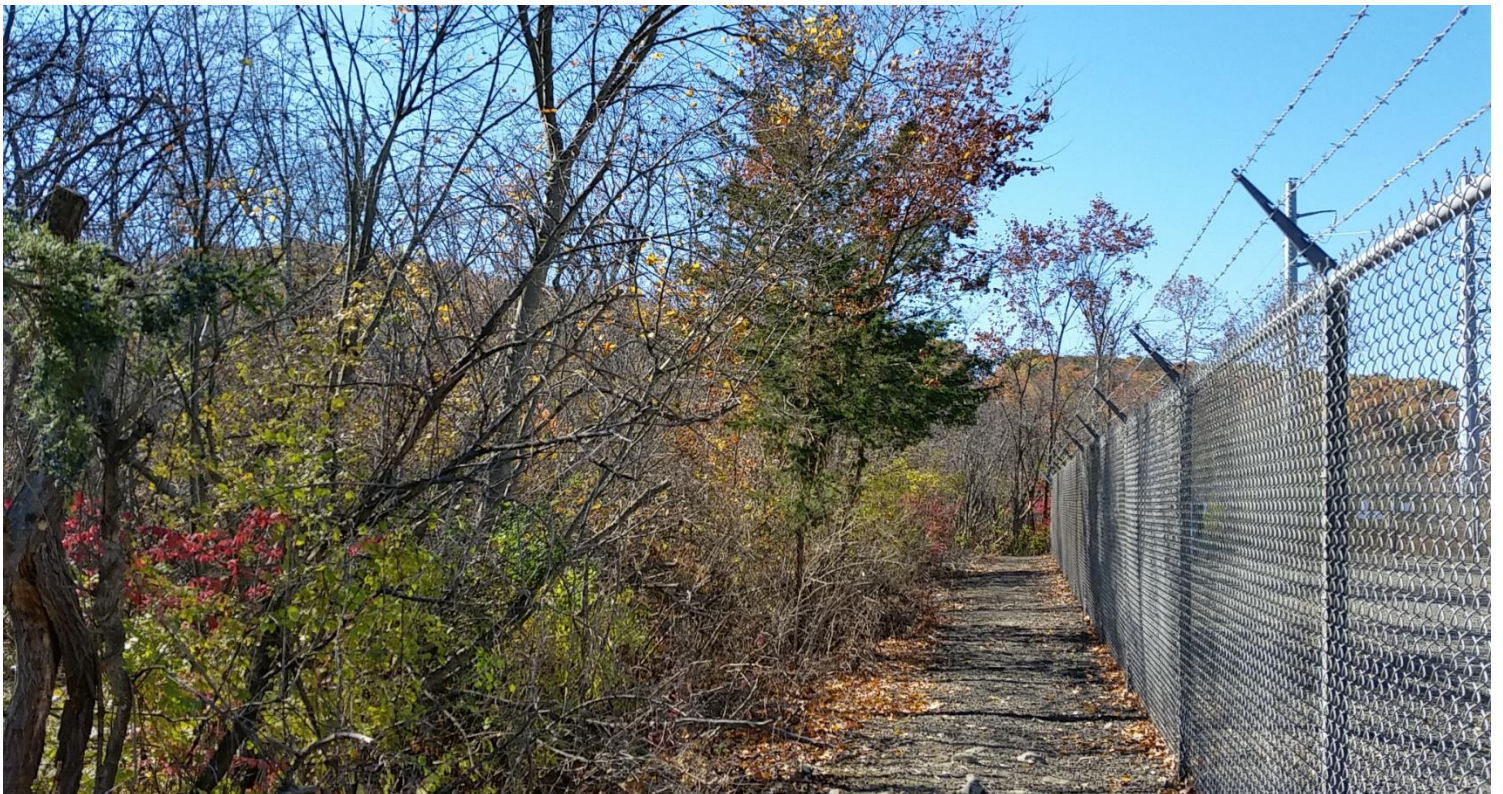
Photo #2: View of Wetland W-1 along the southern edge of the Plumtree Substation where swamp mat access is proposed. The wetland in this portion is a scrub-shrub wetland (PSS) dominated by speckled alder (*Alnus incana*) with only a few mature trees. *Facing West.*

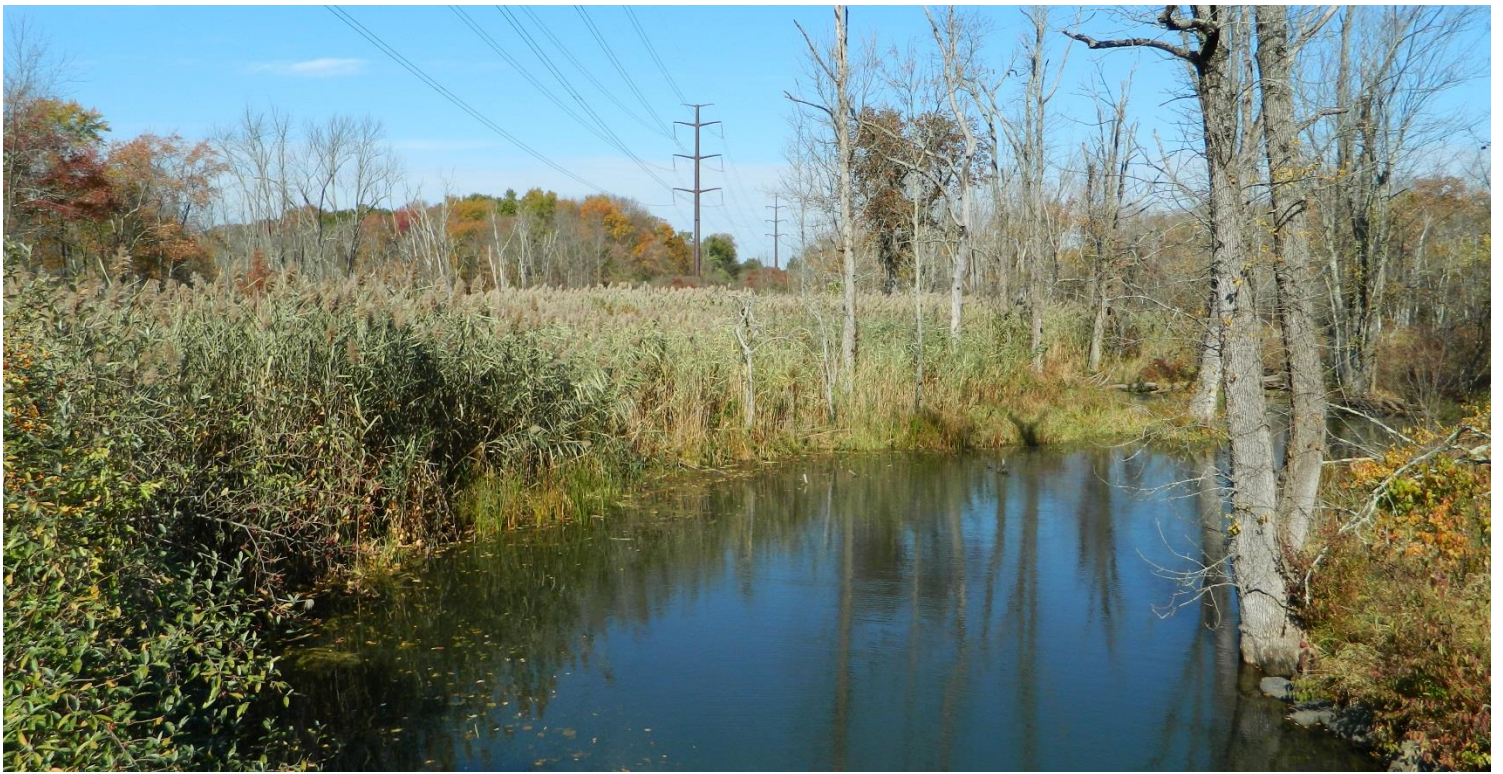
Photo #3: Wetland W-1 a palustrine emergent wetland (PEM) and Lime Kiln Brook a perennial watercourse as seen from Shelter Rock Road. *Facing north.*

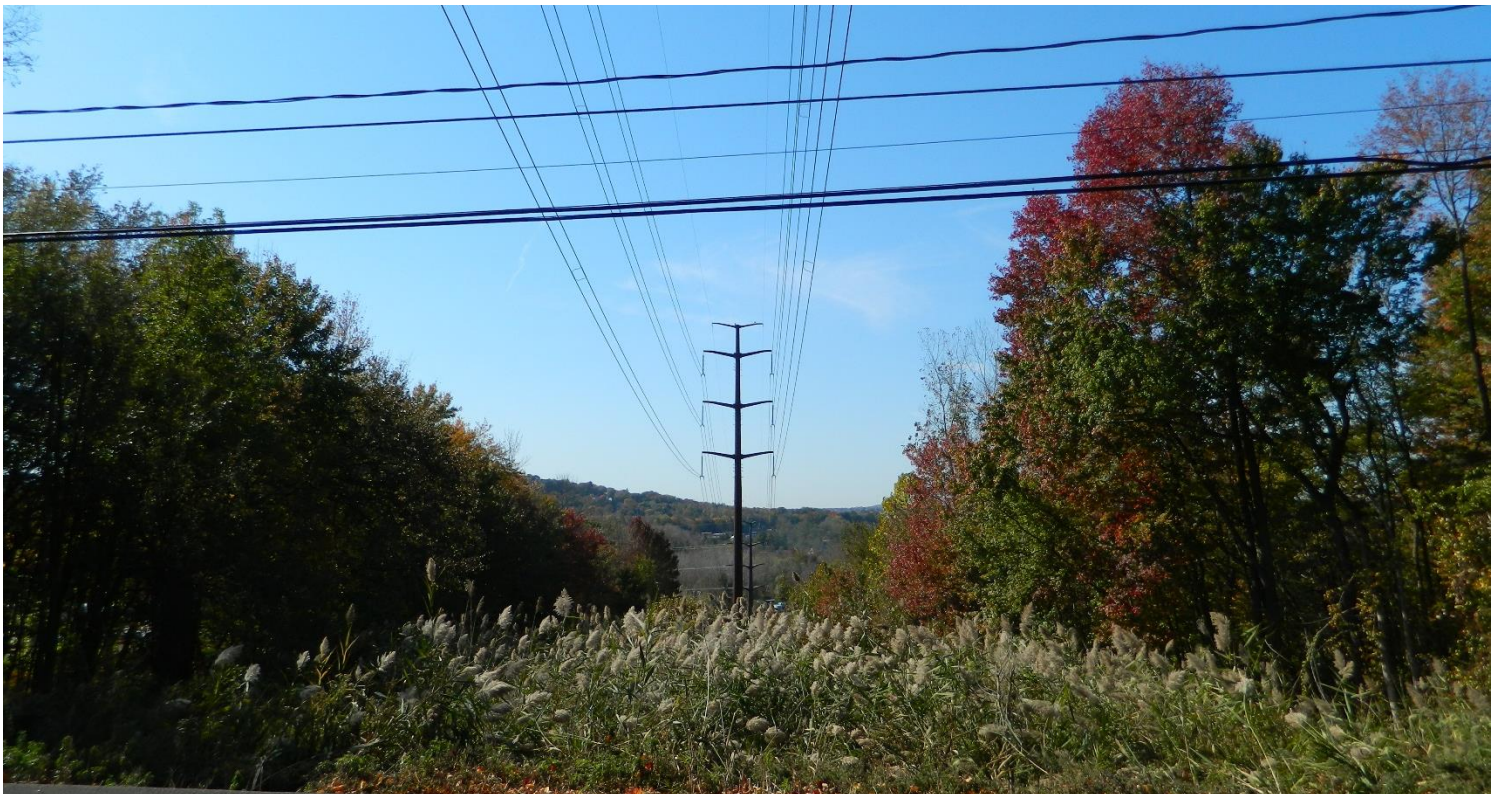
Photo #4: View of Wetland W-2 from Payne Road. W-2 is predominantly a palustrine emergent wetland (PEM) that is forested (PFO) along the northern and southern edges of the Right-of-Way. *Facing west.*

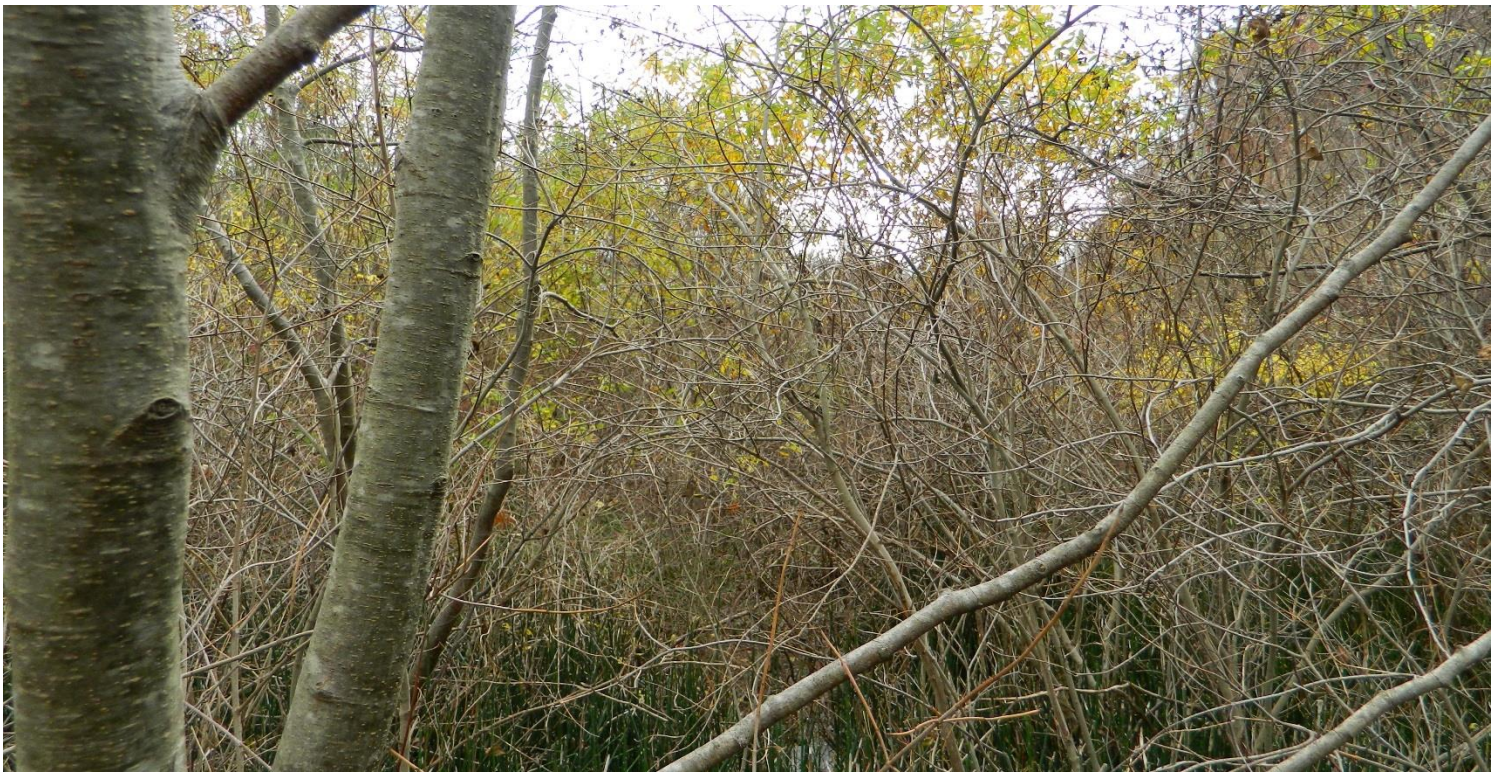
Photo #5: View of Wetland W-3 which is a scrub-shrub-dominated wetland. Stream 5 flows northerly through this wetland ultimately draining into an inlet present to the north of Target. *Facing east.*

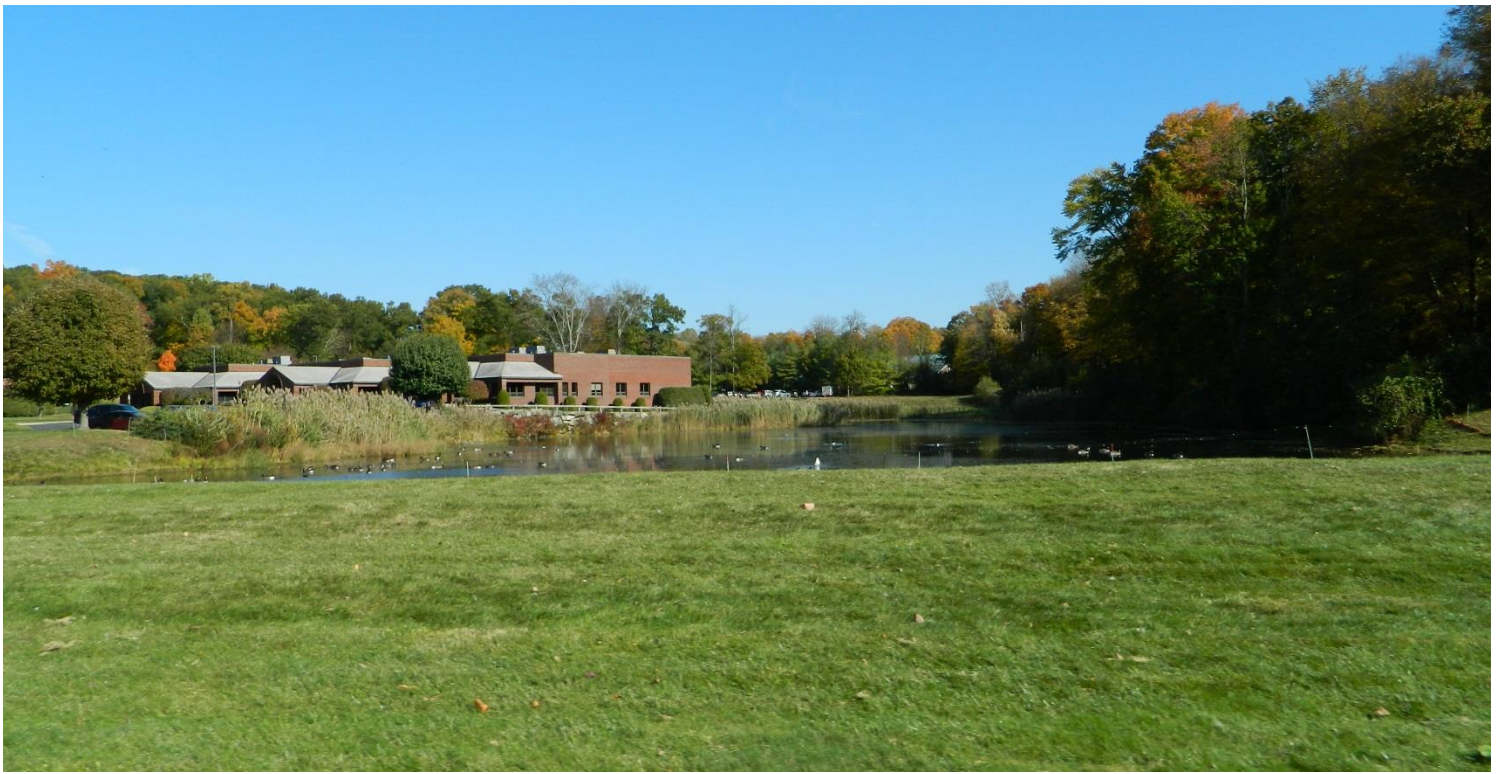
Photo #7: View of Waterbody 1 (WB-1) from Research Drive. The waterbody is an open pond with some patches of palustrine emergent habitat (PEM) along the fringes. *Facing east.*

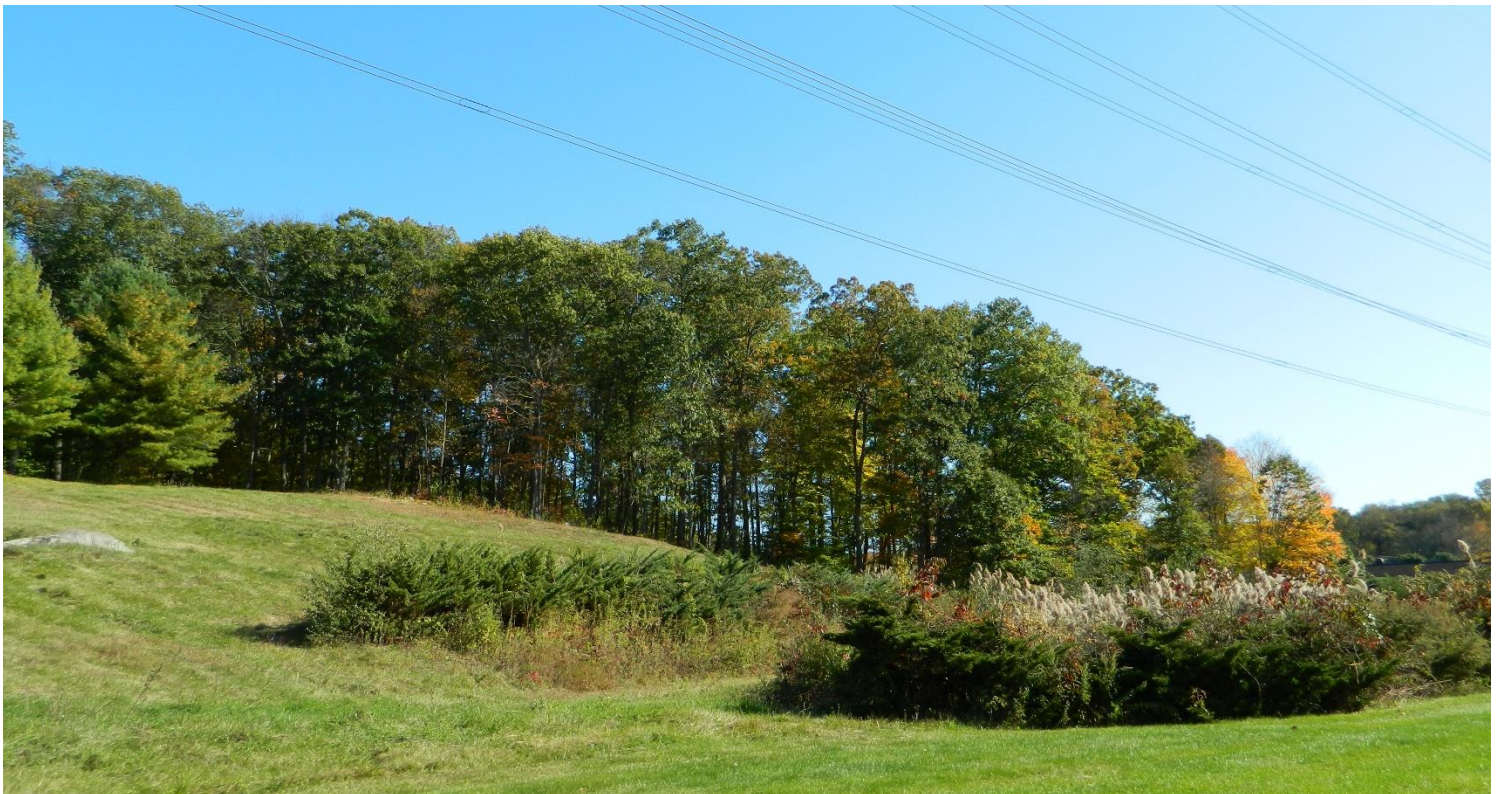
Photo #8: View of Wetland W-5 from Research Drive which is a palustrine emergent (PEM) system. Wetland is dominated by Common Reed (*Phragmites australis*) and is bordered by planted creeping juniper (*Juniperus horizontalis*). *Facing southeast.*

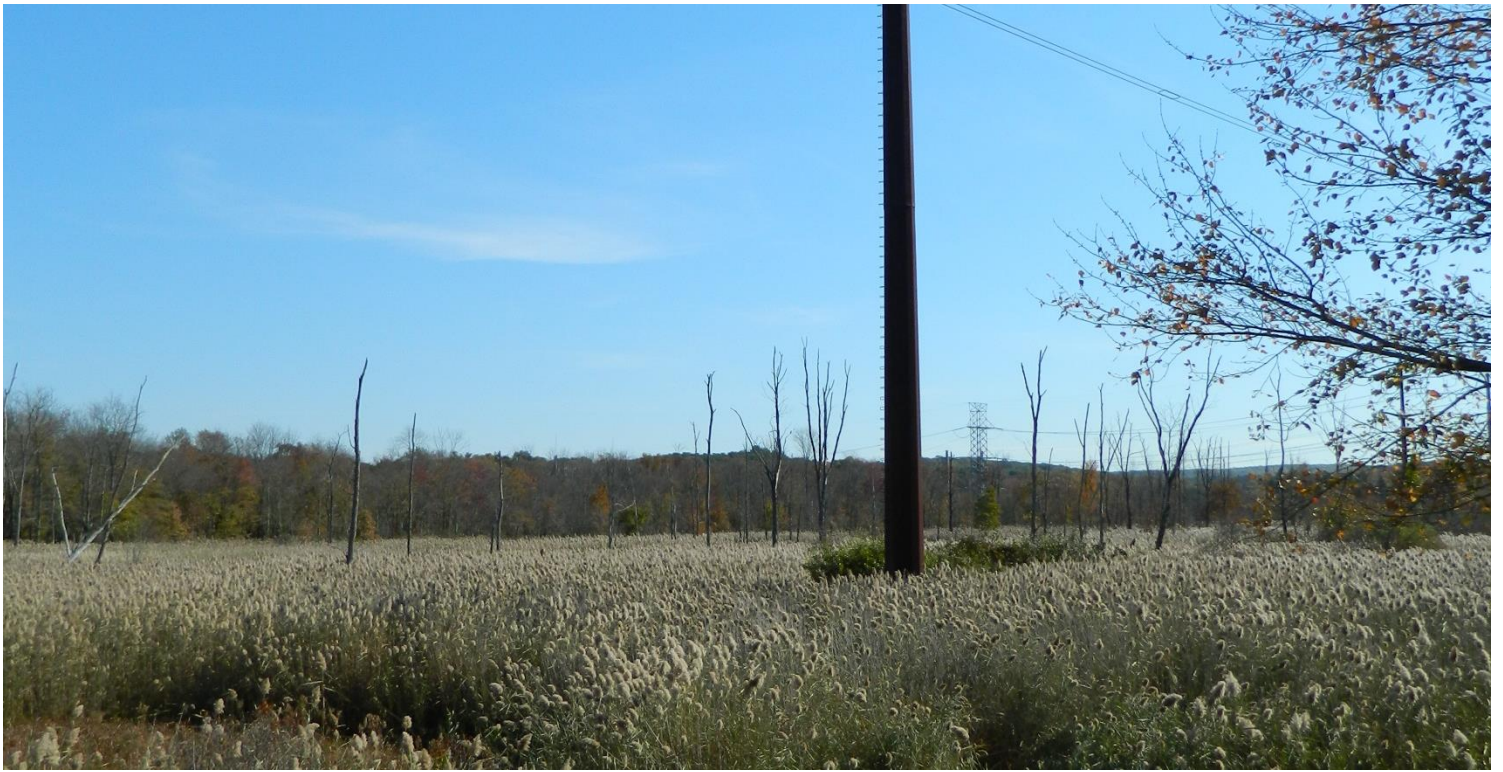
Photo #1: Palustrine emergent habitat (PEM) dominated by common reed (*Phragmites australis*). Palustrine forested (PFO) forest fragments (edge and patch fragments). This system can further be categorized as floodplain forest associated with the East Swamp Brook and Limekiln Brook wetland complex. *Facing southeast towards existing structure 10266.*

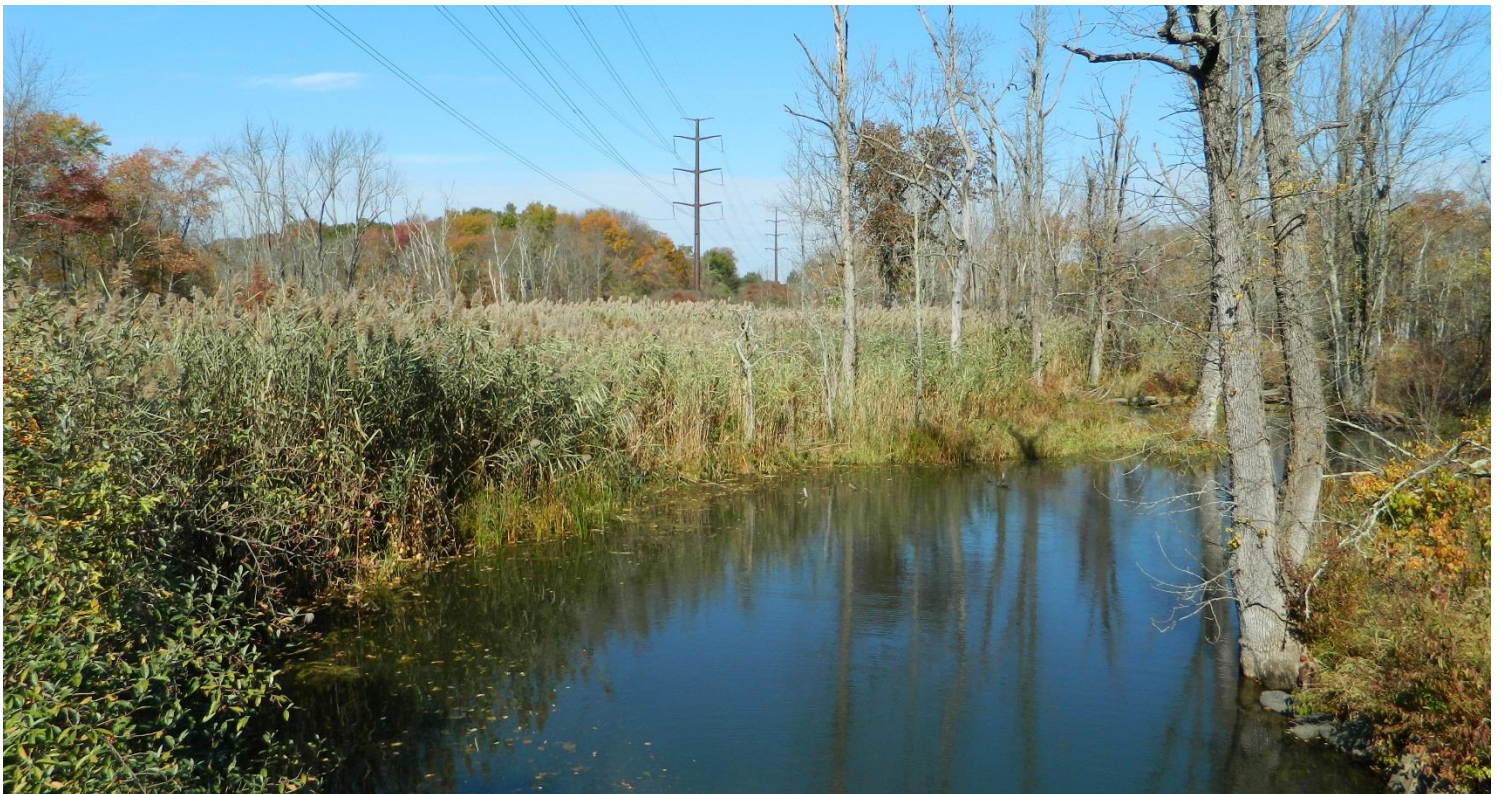
Photo #2: Palustrine emergent habitat associated with East Swamp Brook (shown above) dominated by common reed (*Phragmites australis*). Edge forest adjacent to small Core Forest (<250 acres) is present on either side and represents a palustrine forested community (PFO). *Facing north towards existing structure 10264 from Shelter Rock Road.*

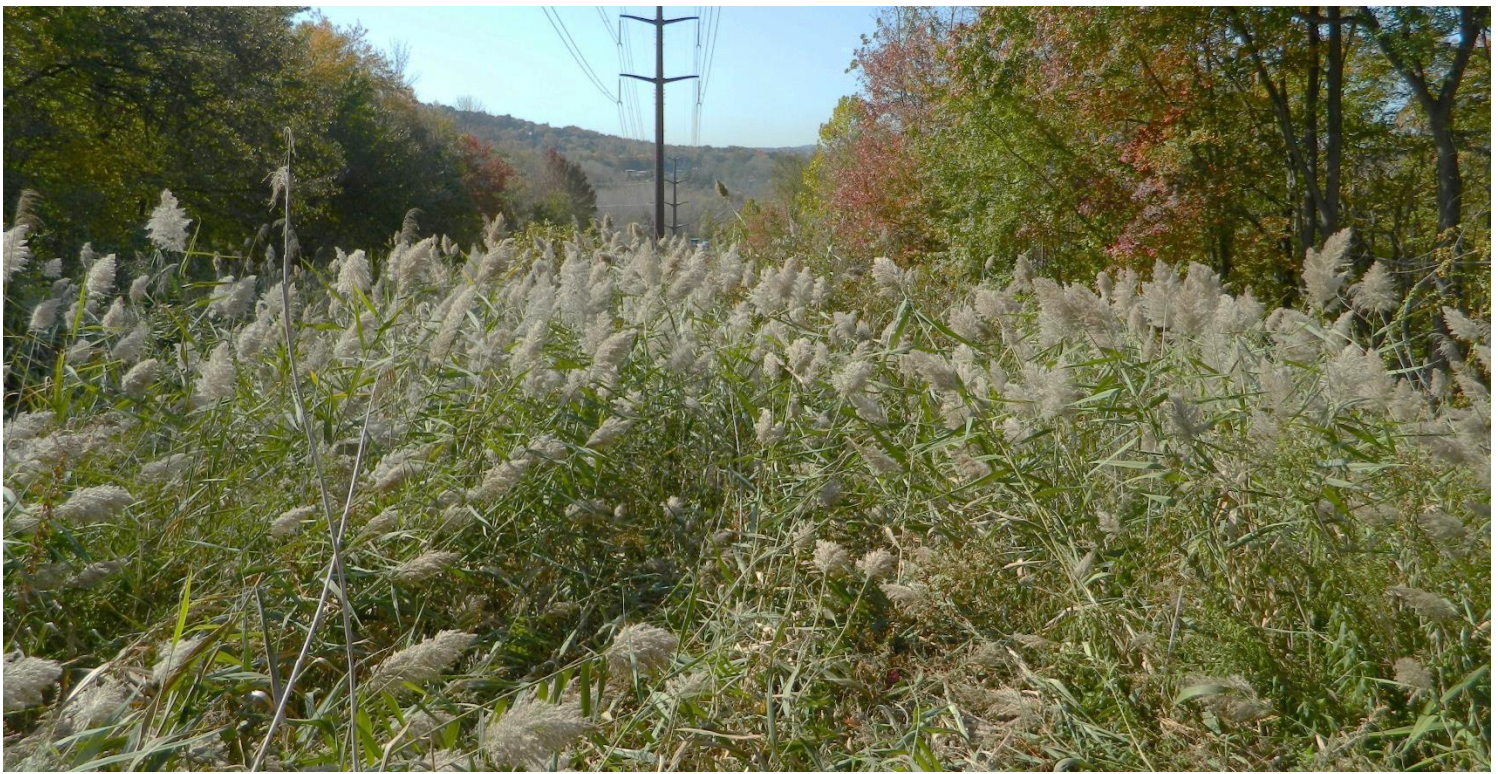
Photo #3: Palustrine emergent habitat (PEM) present within the managed portion of the ROW bordered by patch forest (PFO or upland) are typical in the residential areas from Payne Road to US-6. *Facing west from Payne Road towards existing structure 10259.*

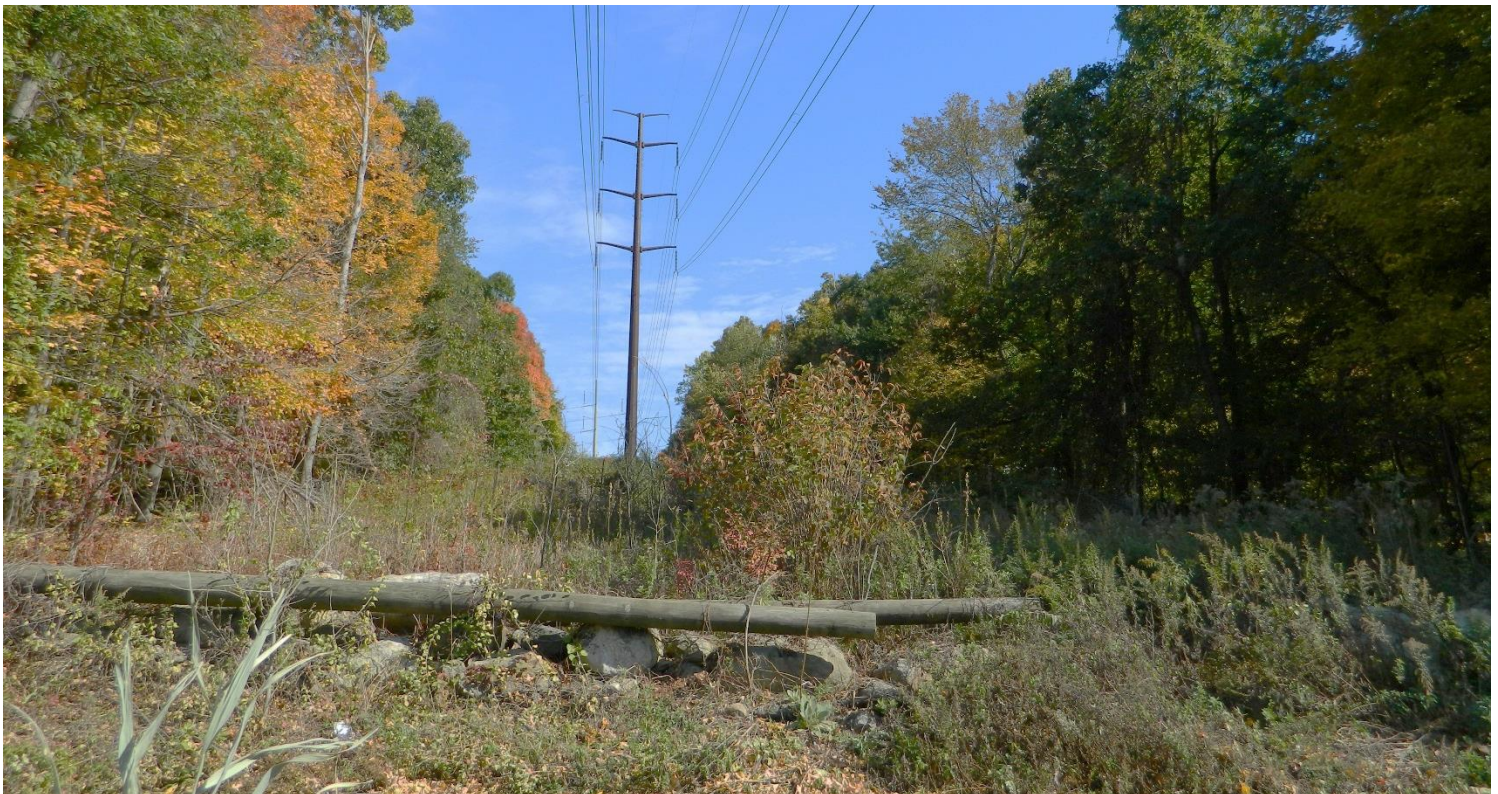
Photo #4: Scrub-shrub habitat within the managed portions of the ROW bordered by patch forest (upland forest) are typical in the residential areas from Payne Road to US-6. *Facing east from Payne Road towards existing structure 10258.*

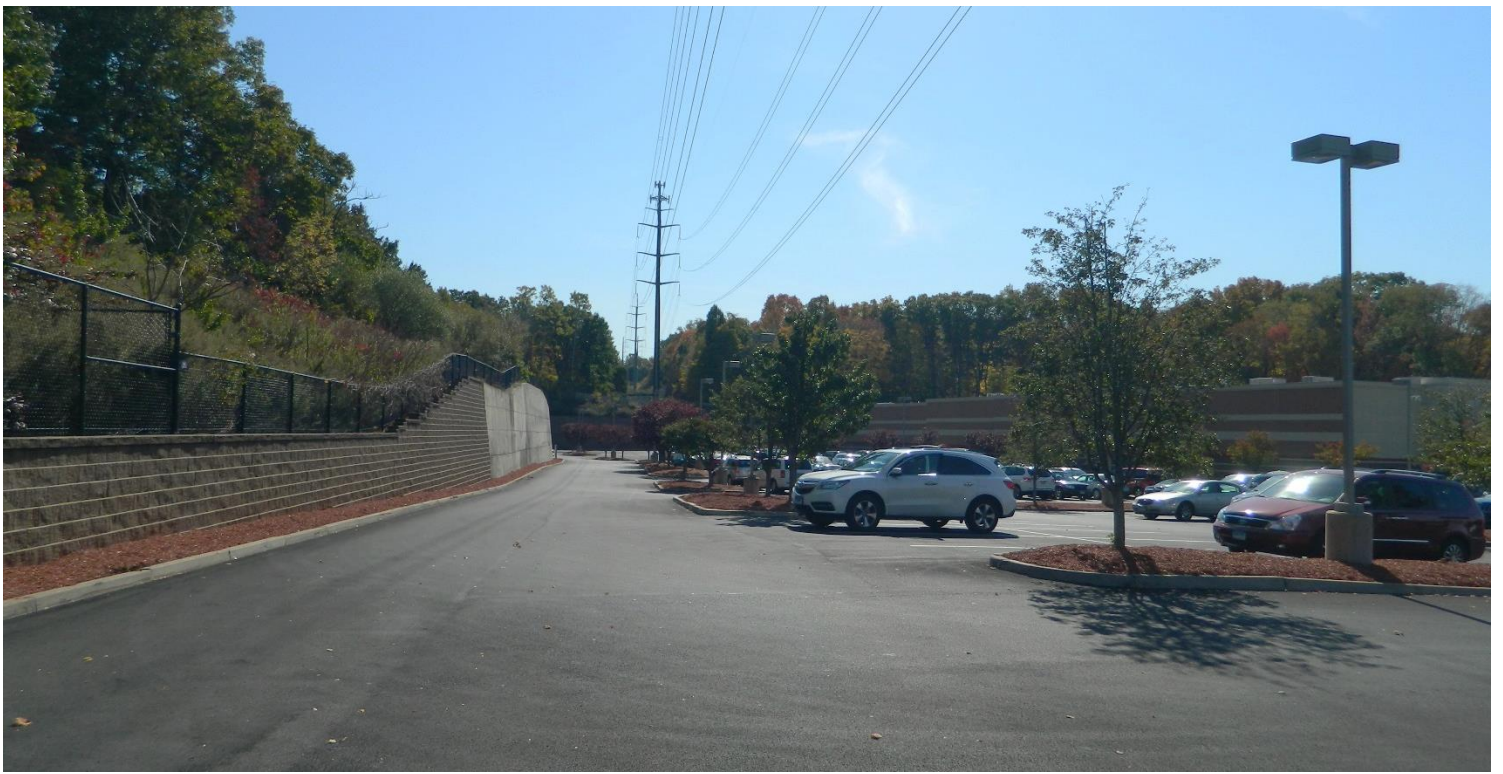
Photo #5: Urban, commercial settings are common on either side of US-6 in Bethel dominated by paved surfaces, buildings, and landscaped environments. Some sparse areas of fragmented (patch) forest is present in these areas. *Facing south from the Target parking lot towards existing structure 10255.*

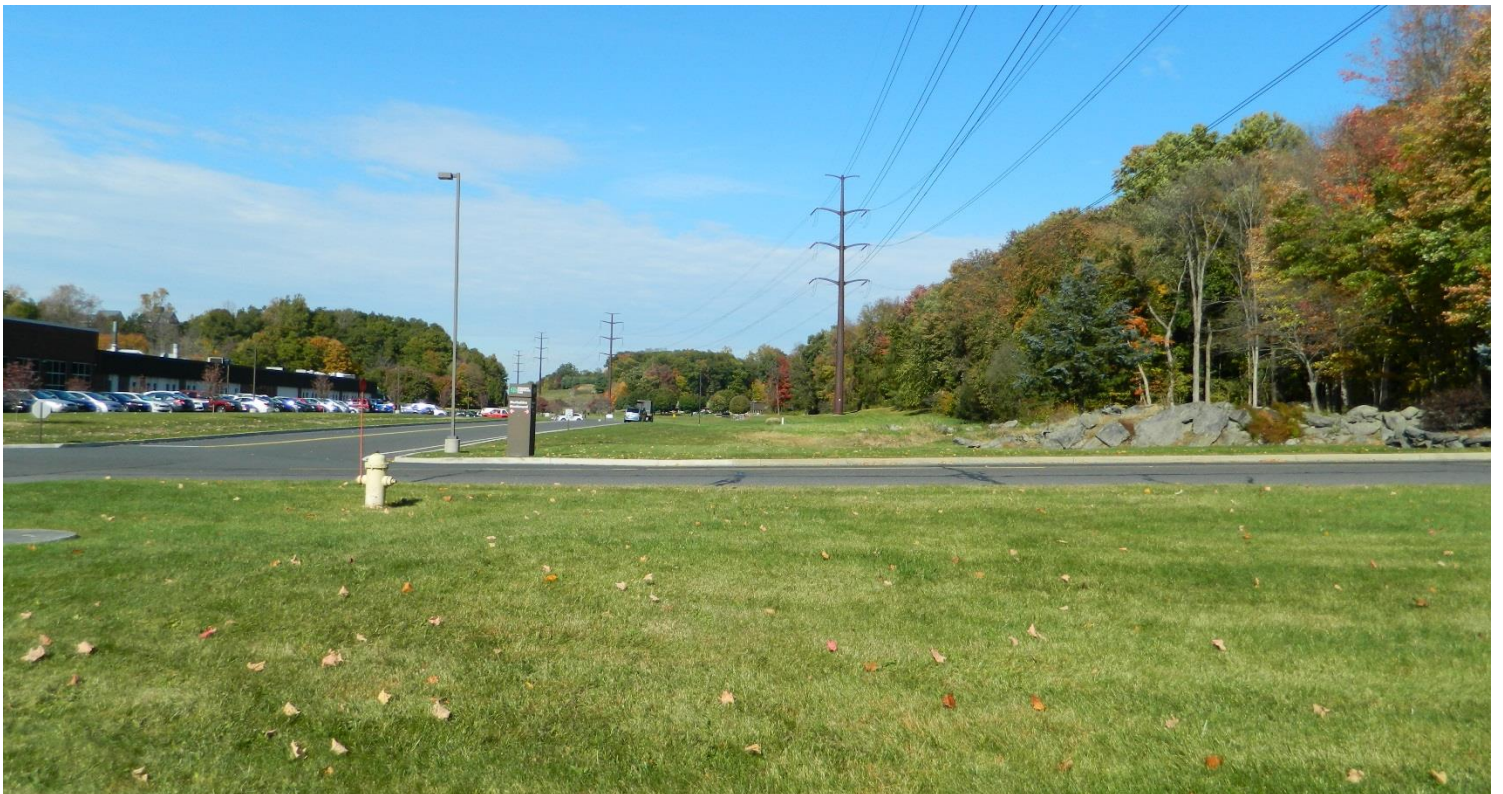
Photo #6: Commercial/industrial land uses dominate north of US-6 in Bethel. These areas consist of land cover of lawn, paved surfaces, and buildings. Forested habitat is typically only present on the east side of the ROW and is comprised of either patch forest or edge forest. *Facing north towards Berkshire Boulevard and existing Structure 10251.*

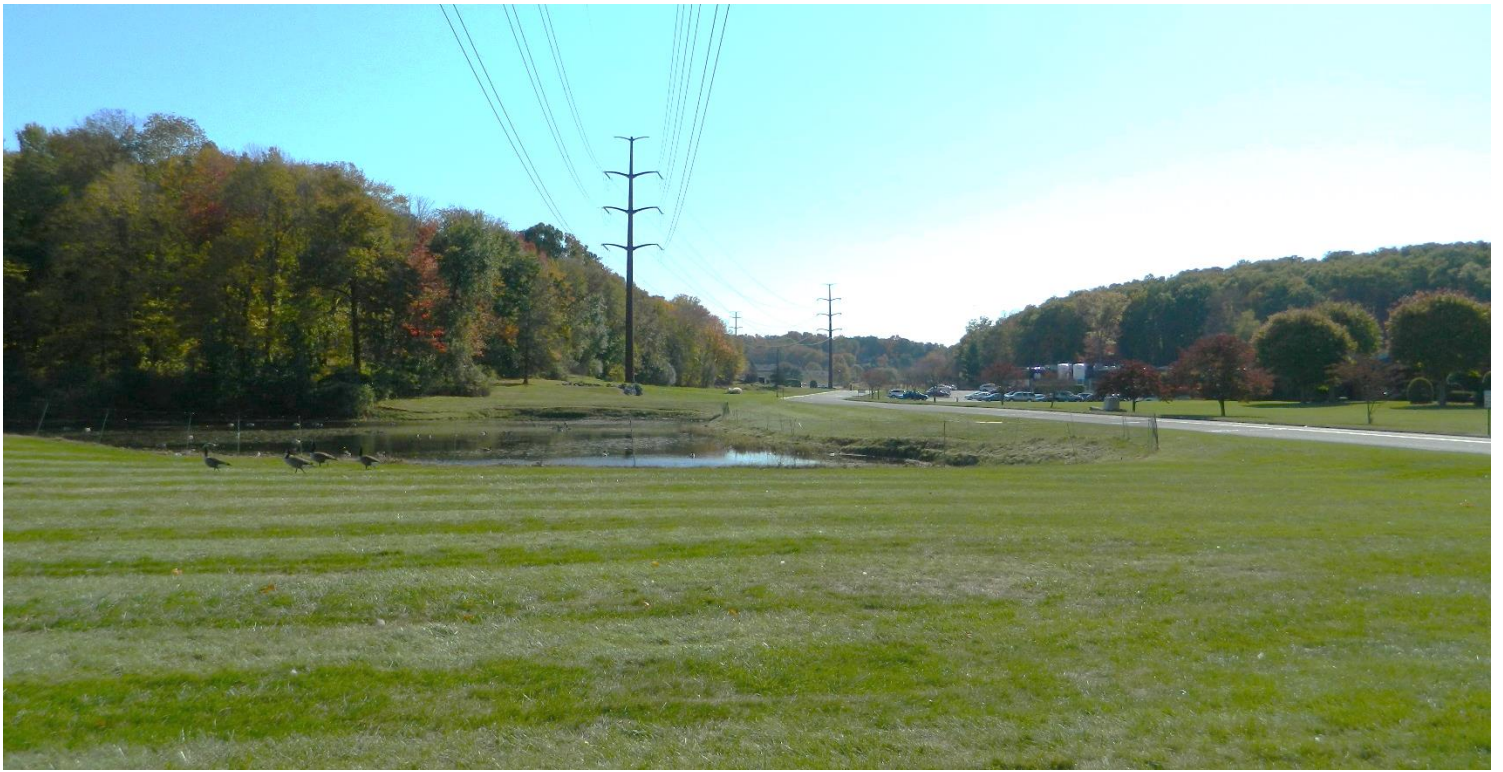
Photo #7: Open water habitat (WB-1) is suitable for Canada goose (*Branta canadensis*), as seen above. This pond is routinely mowed and maintained by the existing commercial development. Facing south from Park Lawn Drive in Bethel towards existing structure 10251.

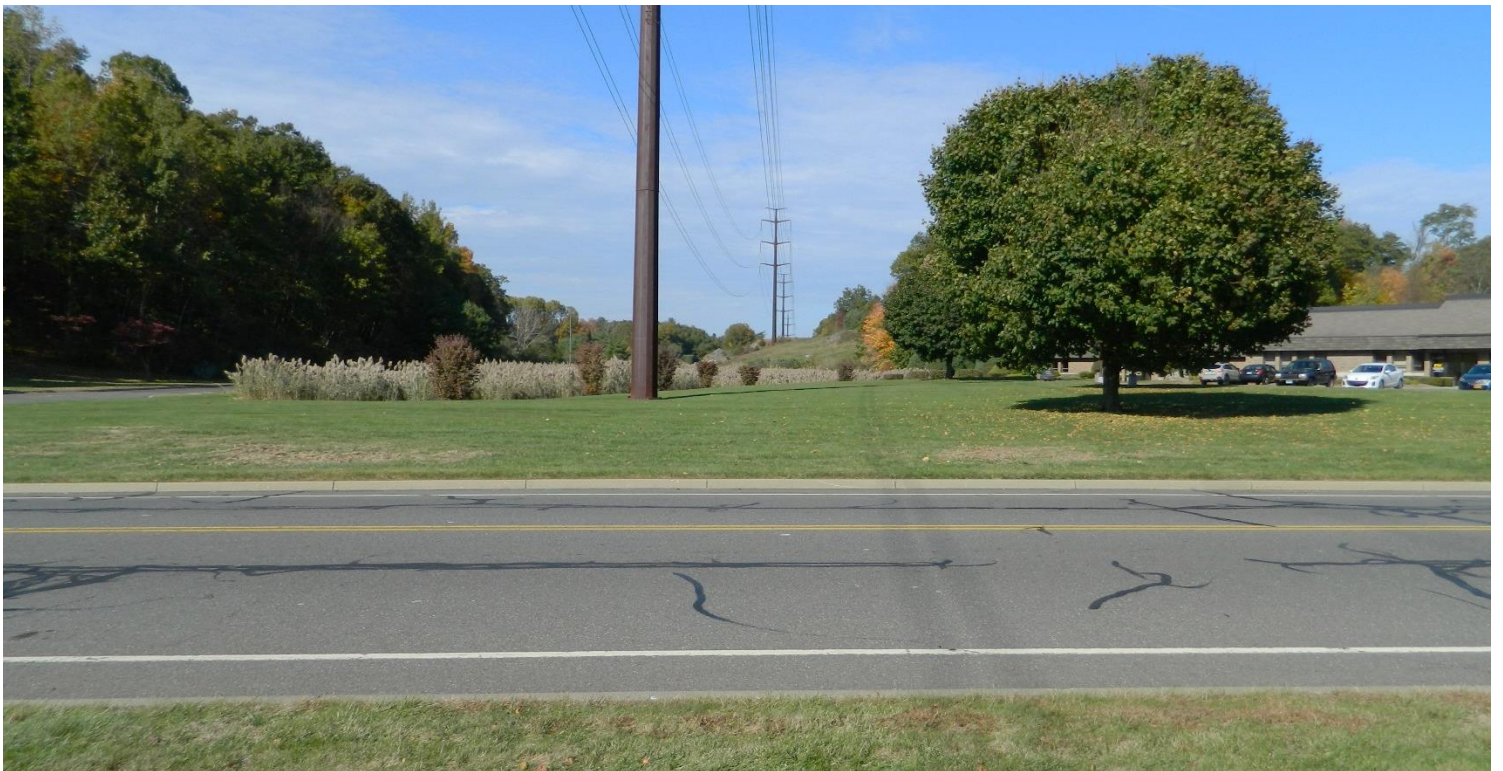
Photo #8: Palustrine emergent habitat in the commercial/industrial areas present to the north of are dominated by common reed (*Phragmites australis*) and are surrounded by a perimeter of planted juniper bushes (*Juniperus sp.*) and surrounded by lawn. The wetlands in this area are mostly armored and at least partially man made and mostly function as stormwater systems for the surrounding development. Facing north from Park Lawn Drive towards existing structure 10250.

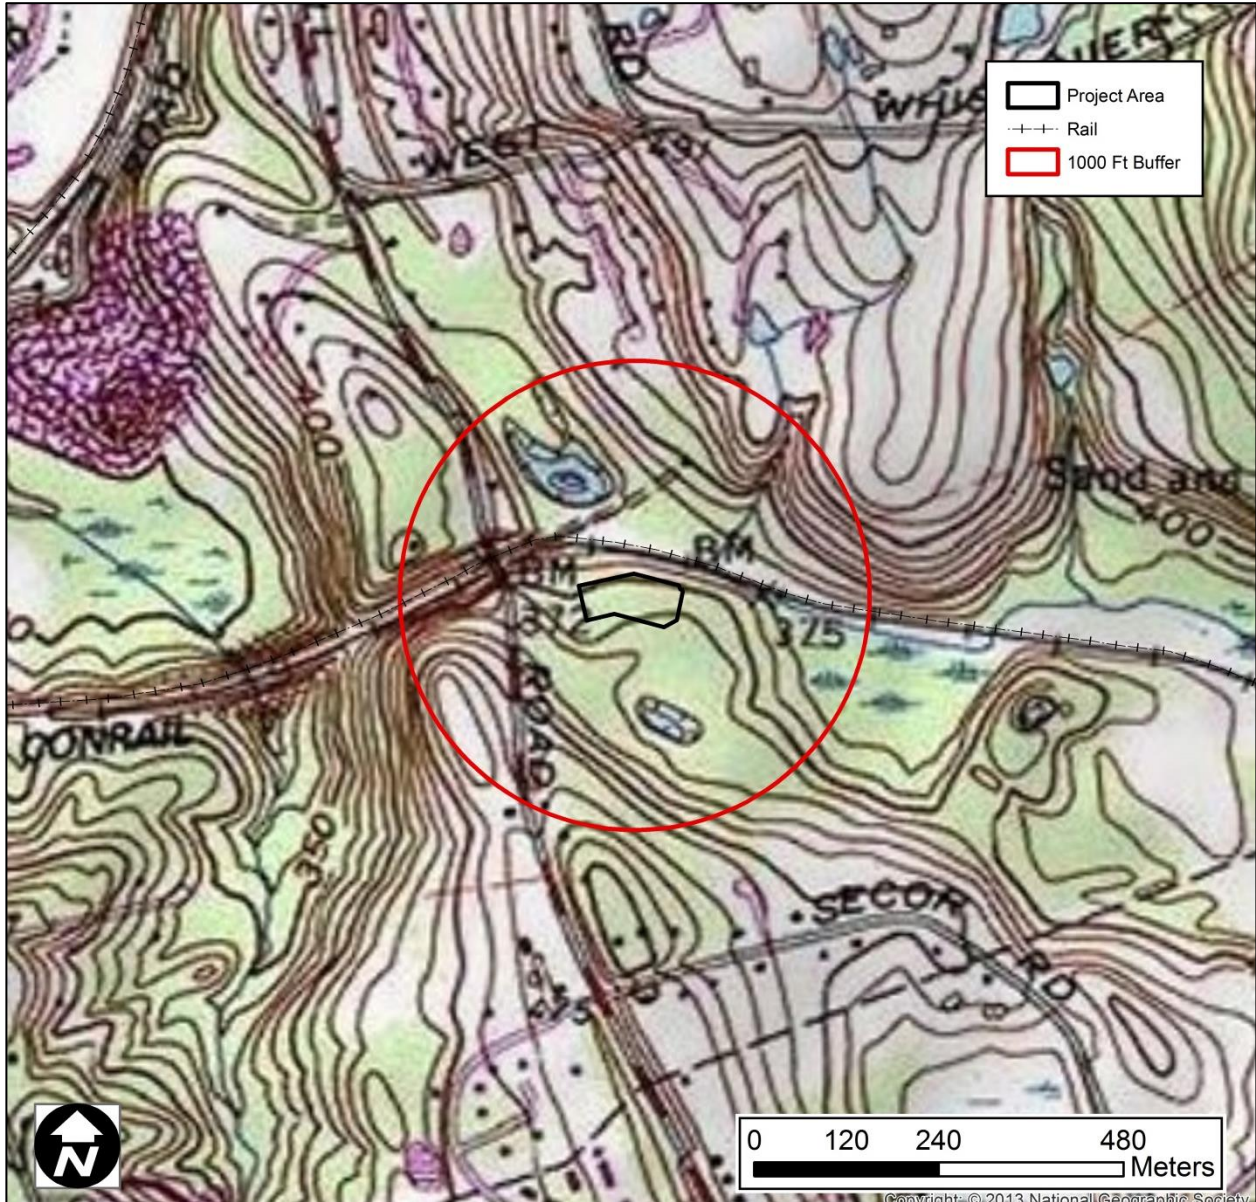
Figure 1, Sheet 1.

Excerpt from a USGS 7.5' series topographic quadrangle image showing the Stony Hill Substation.

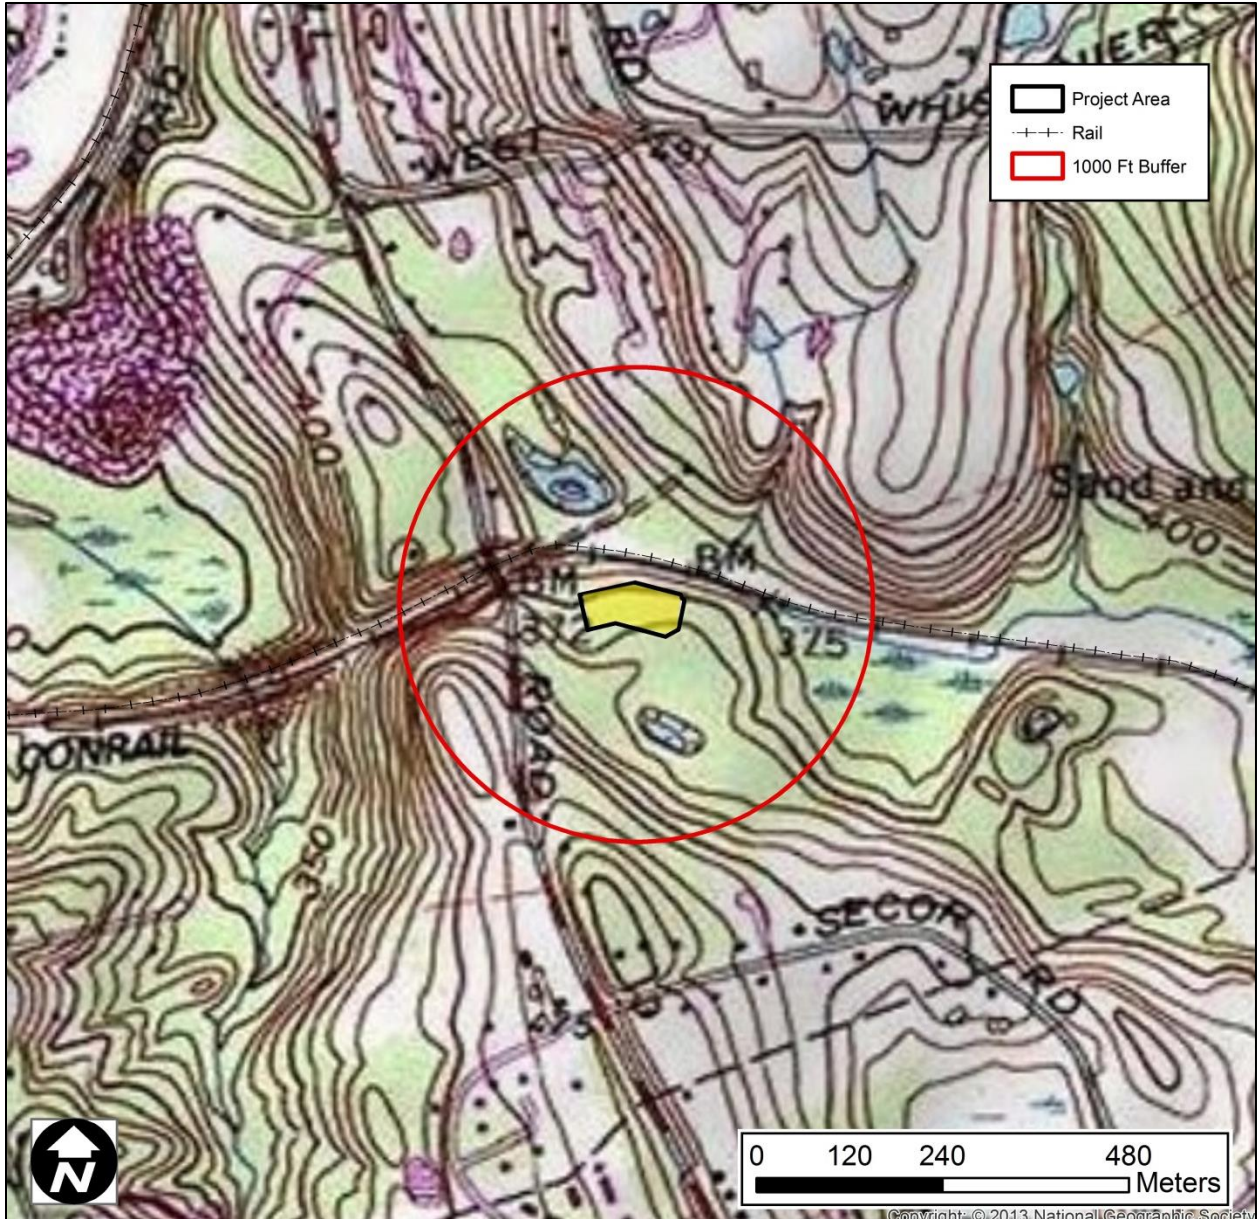
Figure 5, Sheet 1.

Excerpt from a USGS 7.5' series topographical map depicting the archaeological sensitivity of the route of the Stony Hill Substation area (yellow = no/low potential; red = moderate/high potential).
