SOUTHWEST CONNECTICUT RELIABILITY PROJECT

THE CONNECTICUT LIGHT AND POWER COMPANY

VOLUME 2: WETLANDS AND WATERCOURSES REPORT

VOLUME 3: ENVIRONMENTAL

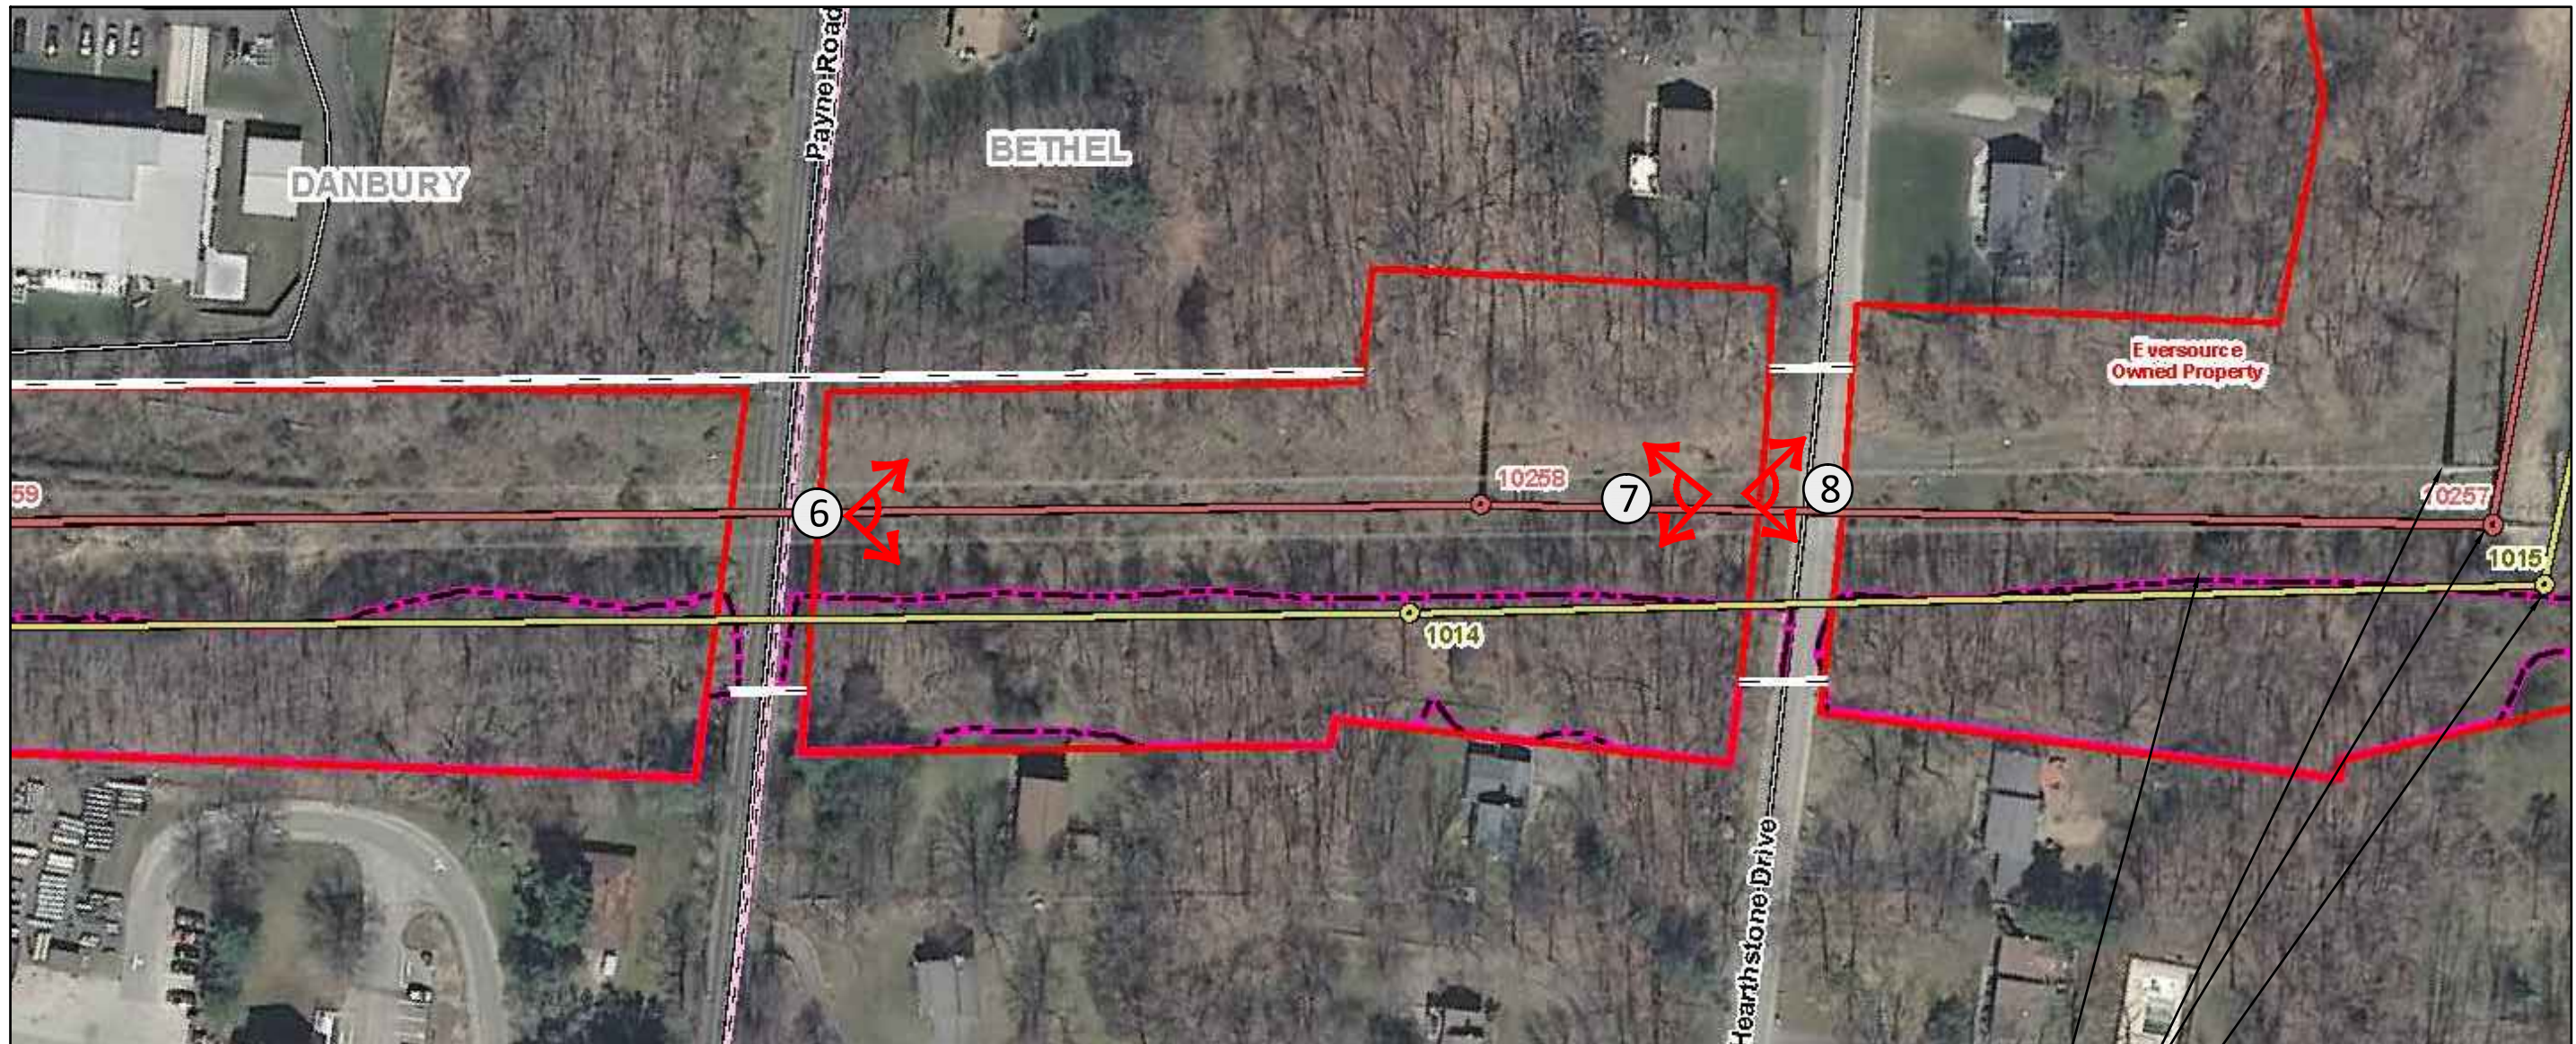
VIEW 6 LOOKING EAST FROM PAYNE RD.
 VIEW 7 LOOKING WEST FROM HEARTHSTONE DR.
 VIEW 8 LOOKING EAST FROM HEARTHSTONE DR.

TREE CLEARING (TYP.)
 EXISTING STRUCTURES (TYP.)
 PROPOSED STRUCTURES (TYP.)

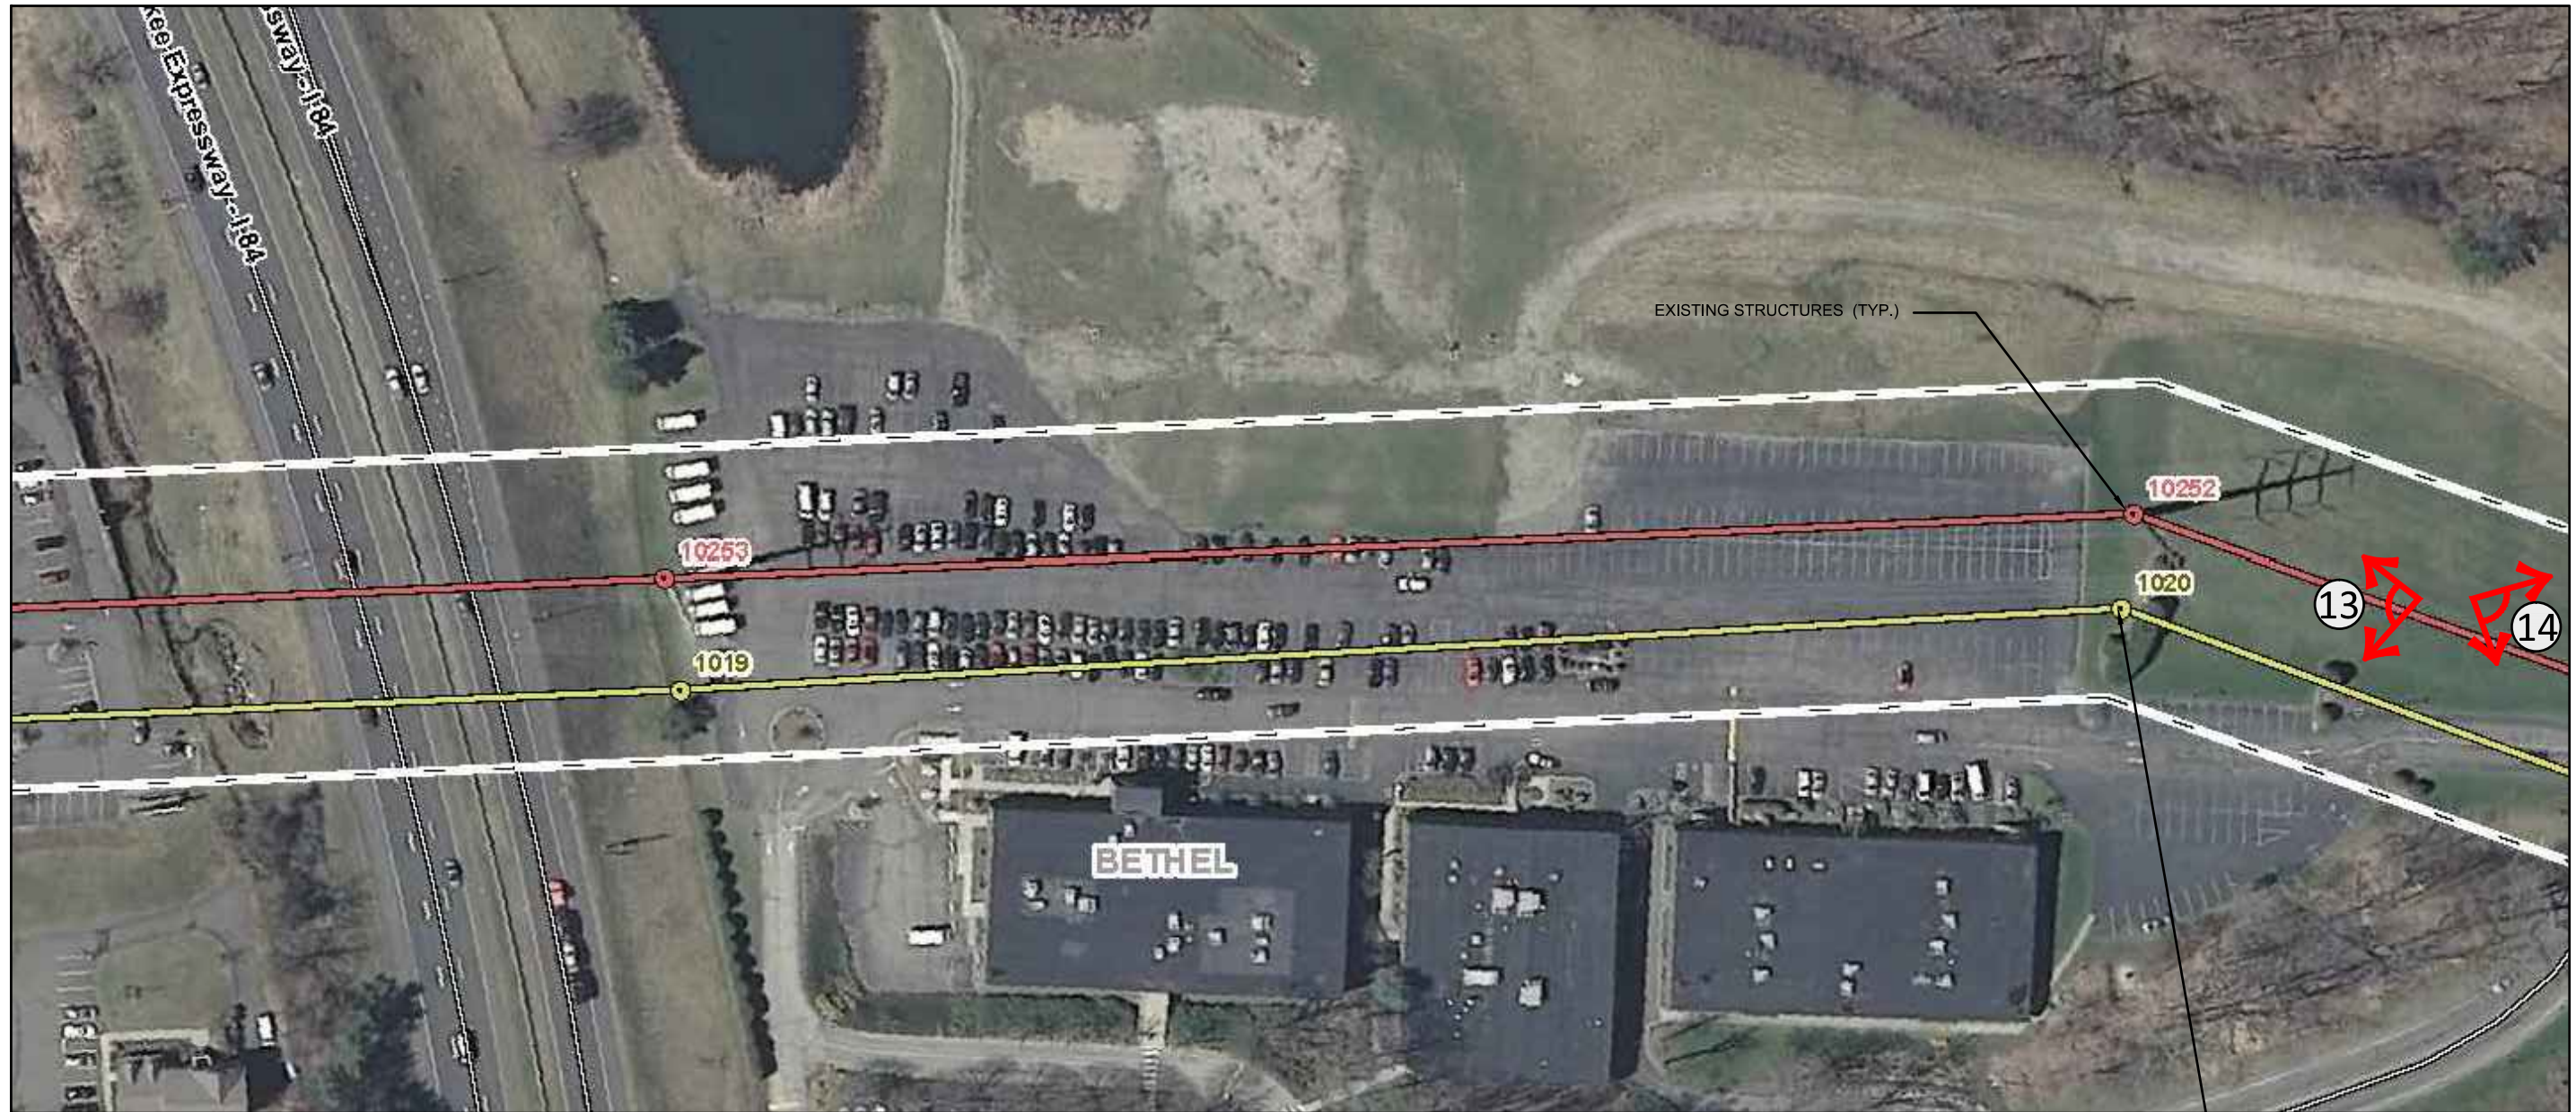
VIEW 13 LOOKING SOUTH FROM BERKSHIRE BLVD.
VIEW 14 LOOKING NORTH FROM BERKSHIRE BLVD.

PROPOSED STRUCTURES (TYP.)
